## Performance Evaluation and Commissioning of a 110V, 440AH VRLA Battery Bank at Dagachhu Hydropower Plant

**Keywords:** VRLA Battery, Commissioning Test, Capacity Test, Impedance Measurement

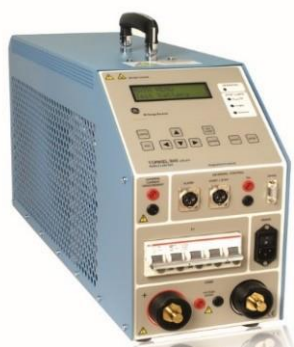
**Fig. 4:** TORCEL 860

Fig. 4 shows that the TORCEL 860 is used to discharge the battery; it is a device primarily intended for capacity testing. It is applicable for systems operating between 12 V and 480 V, and it can discharge at currents of up to 110 A. Subsequently, the BVM (Battery Voltage Monitor) is a device shown in Fig. 5, designed to measure battery voltage, capable of assessing the voltage of individual battery cells, with each unit able to manage up to 20 V. The Megger BITE3 battery impedance tester shown in Fig. 6, assesses the condition of lead-acid cells with a capacity of up to 2000 Ah by measuring key battery parameters. The BITE3 evaluates cell impedance, conducts an internal ohmic test, measures cell voltage, checks intercell

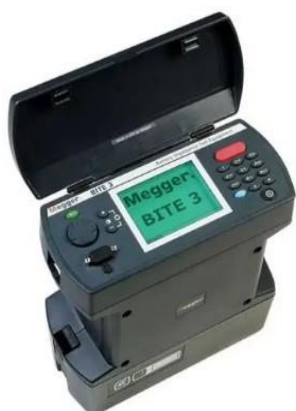
**Fig. 6:** The Megger BITE3 battery impedance tester
